The Post-Mortem of Road Safety Audit Stage 5

Muhammad Marizwan Abdul Manan^{1*}, Norfaizah Mohamad Khaidir¹, Hawa Mohamed Jamil¹, Mohd Shafie Nemmang¹ & Nurulhuda Jamaluddin¹

¹Road Safety Engineering and Environmental Research Centre, Malaysian Institute of Road Safety Research (MIROS), Malaysia

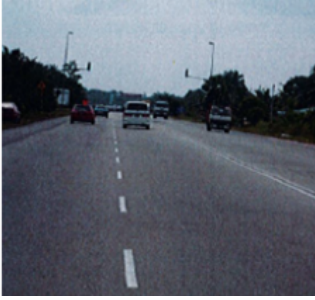
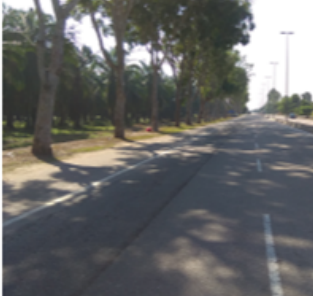
Table 1: Sample finding obtained from RSA Stage 5 revisit at KM 16, F050, Batu Pahat-Kluang, Johor, MALAYSIA

The location is a four-lane single carriageway road during RSA Stage 5 in 2009. High number of access road was observed along the road. Risky and uncontrolled traffic movement was seen by traffic entering and exiting from the main road to access road.	The four-lane single carriageway was upgraded to a four-lane dual carriageway with a concrete median. The traffic movement at the location was improved and safer where the presence of the concrete median able to control the number of access.

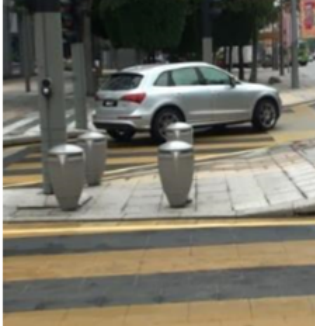
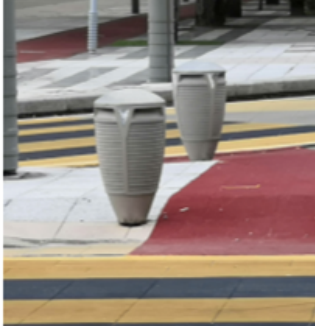
The installation of the bollard aims to prevent the misuse by the motorist. However, the gap between the bollards was insufficient for the bicyclists to manoeuvre the area smoothly.	The distance between the bollards was increased, and enough space was given for bicyclist.

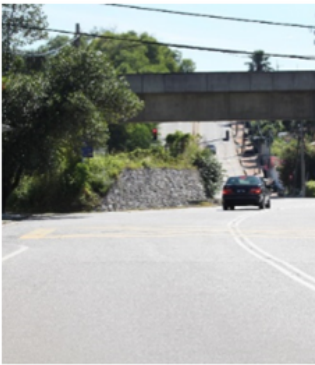
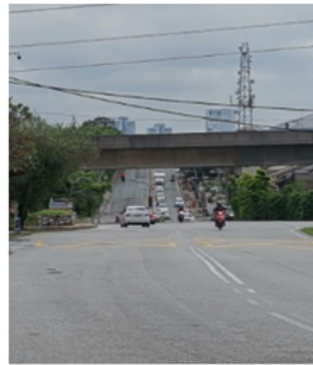
Table 2: Sample finding obtained from RSA Stage 5 revisit at Sea Park, Petaling Jaya, Selangor, MALAYSIA

The road alignment after the curve was not visible by drivers approaching the junction. In other words, the alignment of the of the curve is 'hidden' from the view of drivers who are driving towards the junction.	Based on the recommendation by MIROS in 2010, Majlis Bandaraya Petaling Jaya (MBPJ) has realigned the road to improve the road visibility and sight distance. The realignment not only enhanced the visibility of road alignment approaching the signalized junction, but it also improves decision sight distance of the said junction.
