The Post-Mortem of Road Safety Audit Stage 5

Muhammad Marizwan Abdul Manan^{1*}, Norfaizah Mohamad Khaidir¹, Hawa Mohamed Jamil¹, Mohd Shafie Nemmang¹ & Nurulhuda Jamaluddin¹

¹Road Safety Engineering and Environmental Research Centre, Malaysian Institute of Road Safety Research (MIROS), Malaysia

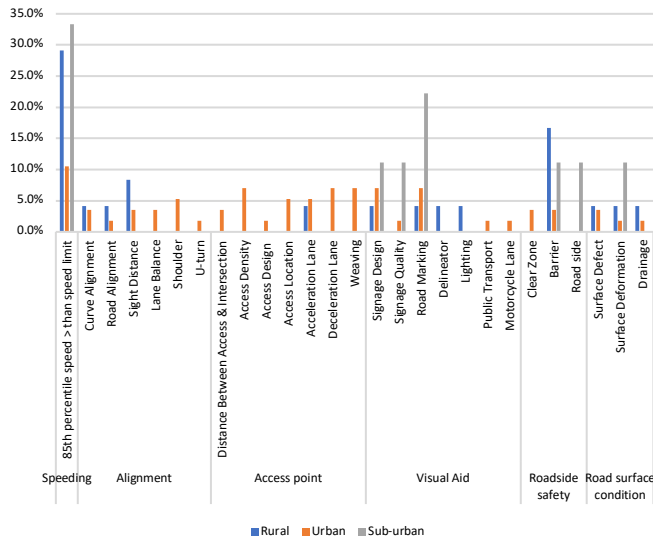
Figure 3: Percentage of reported road safety deficiencies issues on cases along expressways

Figure 3 shows the percentage of reported road safety deficiencies issues based on the 18 cases (i.e., seven (7) cases on rural, eight (8) cases on urban and 3 cases on sub-urban) from the reviewed RSA stage 5 conducted along expressway. In general, the highest percentage of deficiencies issues being reported on RSA Stage 5 works along expressways are related to access points (24.4%) (see Figure 3). However, if we analyzed based on the location of the expressways, speeding issues was the most frequently reported on rural expressways (29.2%), access point deficiencies on urban expressway (36.8%) while visual aid deficiencies are more along sub-urban expressways (44.4%). On a special note, besides speeding issues, rural expressways have also more issues related to the safety of roadside barriers. In urban expressway, the major problem was more on access point

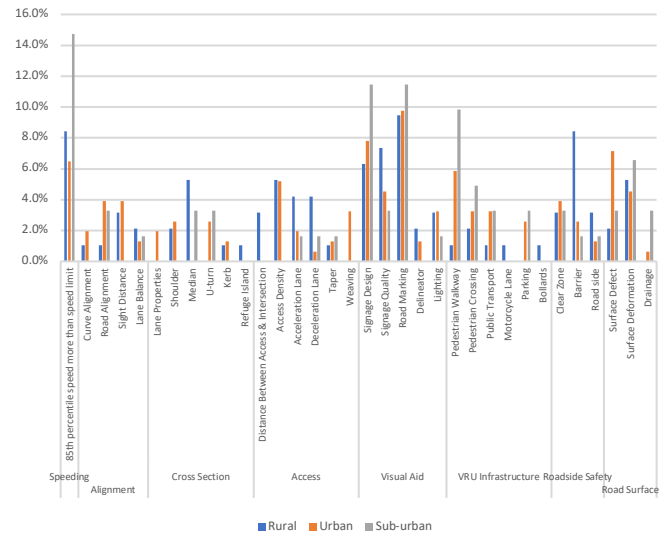
Figure 4: Common deficiencies at non-expressways

From the RSA Stage 5 reports, we gather that, non-expressways (i.e. Primary, Secondary, Collector and Local or Municipal roads) have more issues related to visual aid, i.e., deficiencies in road marking and signages, compared to deficiencies along expressways. As for non-expressway road, a total of 49 cases were analysed which includes 14 cases in rural area, 23 cases in urban area and 12 cases in sub-urban area. All types of areas show that deficiencies on visual aid are consistently high (28.4% for Rural, 26.6% for Urban and 27.9% for Sub-urban) (see Figure 4). The most-reported deficiencies related to visual aid are faded road marking, absence of signage, improper signage location, inadequate number of signage and road marking, vandalized and blocked signage. On the other hand, non-highway on sub-urban areas reported many cases of speeding issues, which has the rate of 14.8% from the total number of issues. At the same time, roadside safety deficiencies such as damaged barriers, inappropriate barrier type, insufficient barrier height and absence of barrier, are more reported in the RSA Stage 5 reports on non-expressways along rural areas (14.7%).

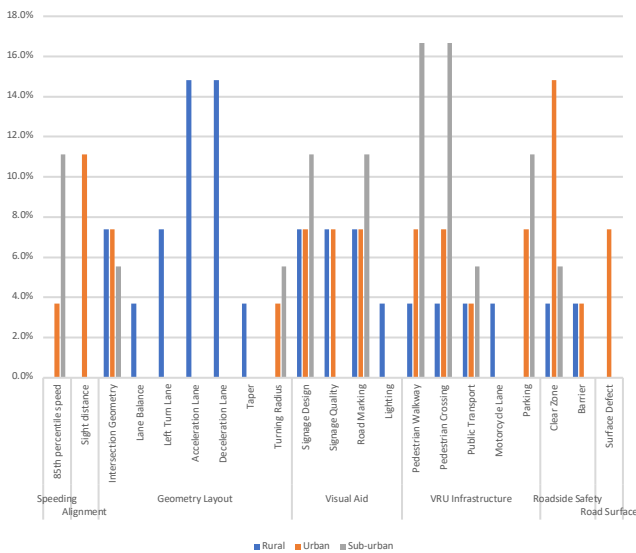
Figure 5: Common deficiencies at un-signalized junction

In general, un-signalized junction has more issues related to the deficiencies on the vulnerable road user’s (VRU) infrastructure. Figure 5 shows the main deficiencies at un-signalized junctions in urban (n=5), rural (n=4) and sub-urban (n=3) areas. Most un-signalized junction have issues with VRU infrastructure (27.8%) such as discontinuity of walkway, absence of pedestrian crossing and illegal parking at junction. Second highest issue was visual aid (23.6%) which includes faded road marking, vandalized signage, inadequate or absence of signage to warn or inform drivers of the road condition ahead and signage installed at improper locations.

In terms of area, un-signalized junction in rural areas have issues on geometry layout deficiencies (51.9%) where, lack of acceleration and deceleration lanes were recorded the highest (see Figure 5). Based on the analysis, most (15%-20%) of the audited un-signalized junctions along rural areas, do not have acceleration or deceleration lane where required, and has insufficient length of acceleration or deceleration lane. In urban area, clear zone within junction seems to be the most common issues where limited space was available for sufficient clear zone. For sub-urban area, highest frequency of deficiencies was observed for VRU infrastructure.

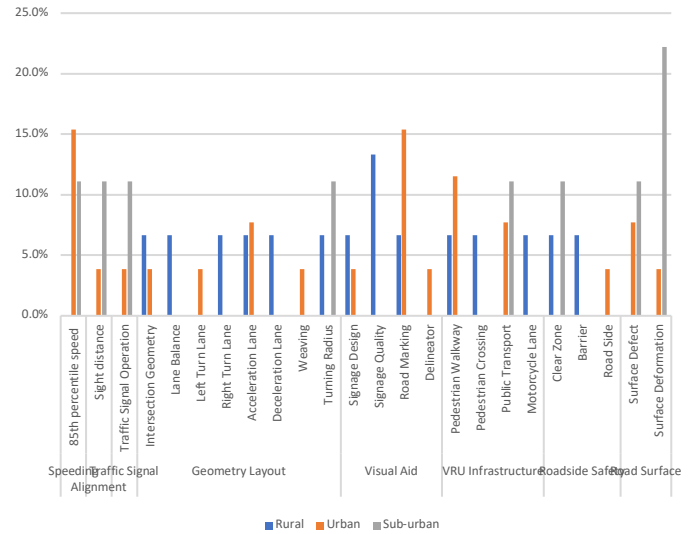
Figure 6: Common deficiencies at signalized junction

For signalized junction, most of the deficiencies occurred at urban area, with issues pertaining to visual aid are the most reported (see Figure 6). Other than that, geometric layout issue (e.g., inadequate right turn lane length, inappropriate lane balance, insufficient lane balance, etc.) was also highly reported on rural signalized junctions. Other safety issues concern at rural signalized junction are flaws in VRU infrastructure (20.0%) and in roadside safety measures (13.3%). For sub-urban signalized junction, frequent deficiencies were centered at road surface defects (33.3%), speeding behavior, inappropriate road alignment and traffic signal operation.
